Fire & Rescue NSW

FRNSW Site Improvement Plan Armidale - Retention Pond

February 2019

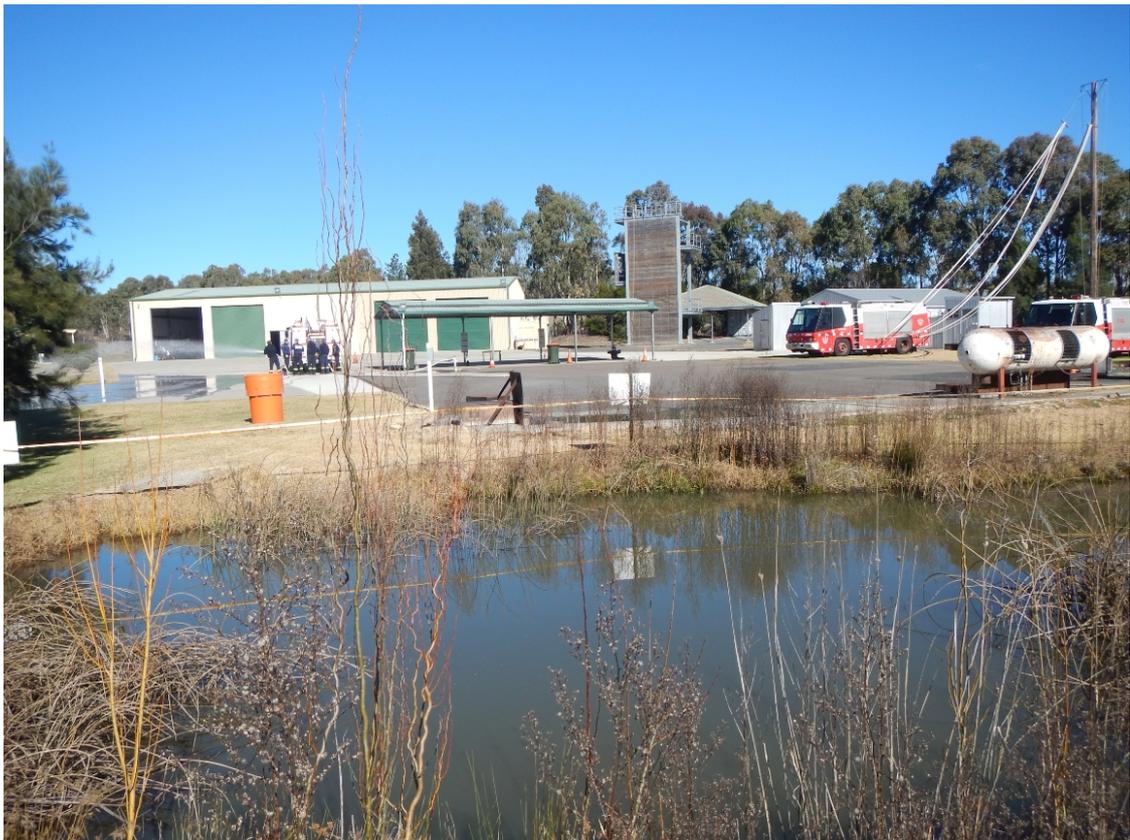
Figure 6-1 Facing south, showing the pond and the central fire training area

The surface area of the pond is approximately 96 m² (based on the dimension 16 m x 6 m, measured based on aerial photographs). For the purpose of this document, an average depth of 1 m to 2 m has been assumed. The volume of water in the pond would therefore range from approximately 96 m³ to 192 m³ (96,000 L to 192,000 L).

Photographs of the pond are shown in Figure 6-1 and Figure 6-2.

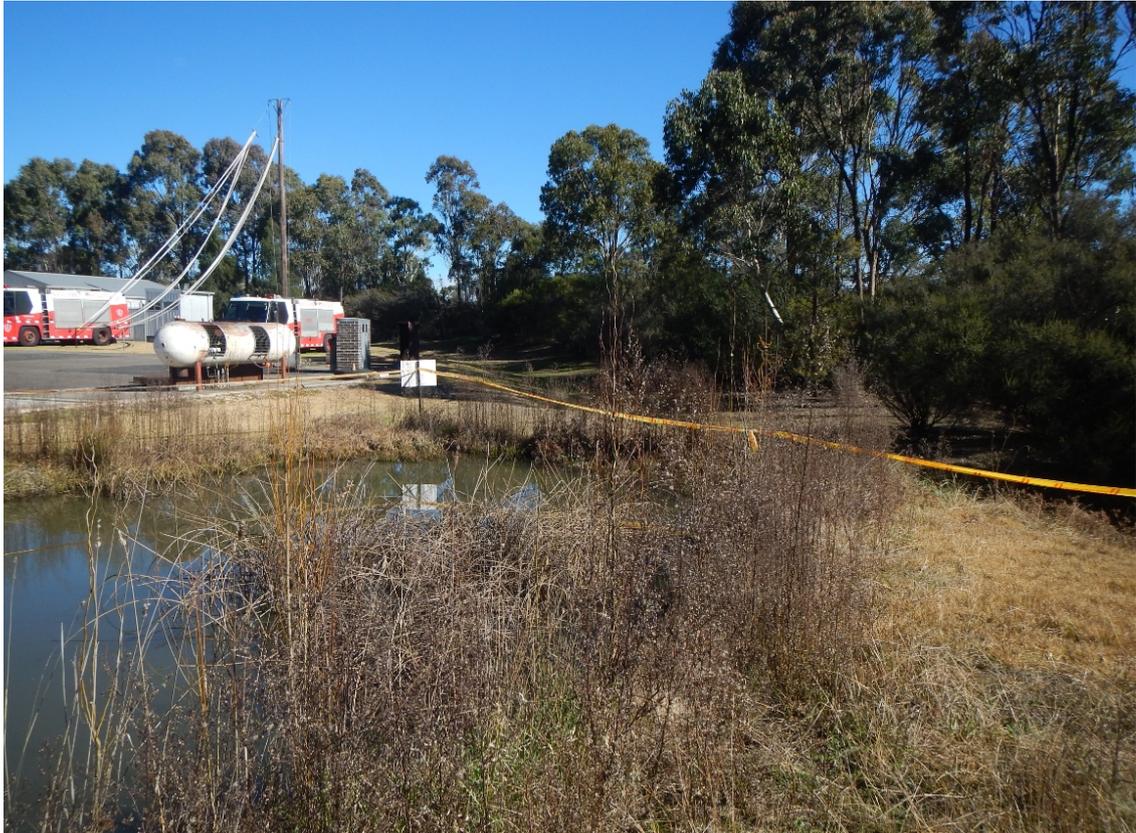
Figure 6-2 Facing west, showing the drainage swale passing to the west of the pond

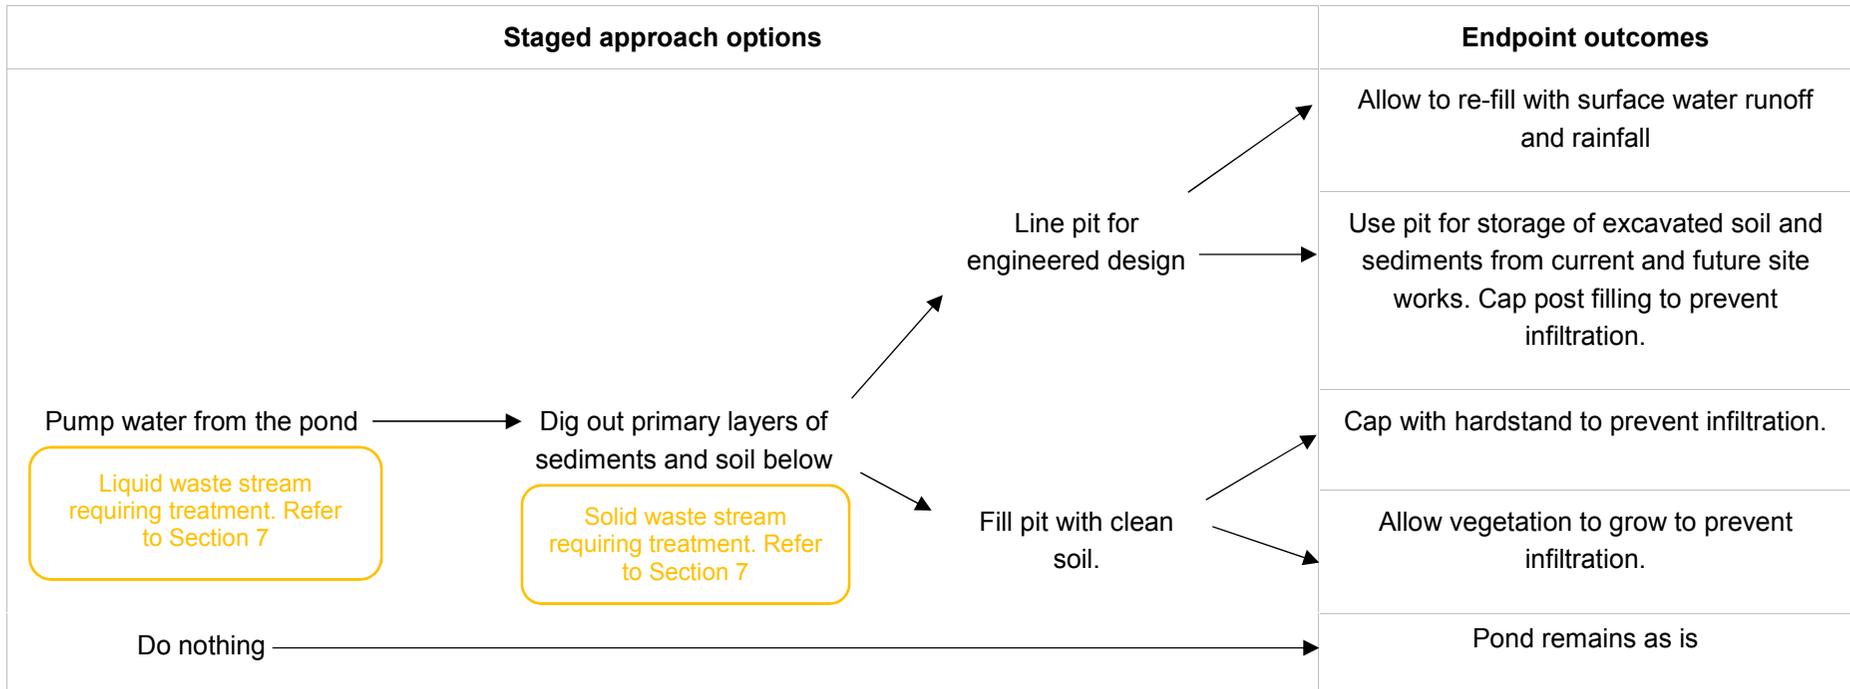
Figure 6-3 Flow chart showing pond option approaches

Based on the functional requirements and improvement goals outlined in Section 6.1 and Section 6.2 (respectively), potential options for addressing surface water and sediment contamination associated with the retention basin are shown in Figure 6-3. Each option would require a staged approach with further options in the final form of the retention basin area.

In order to appraise the above-mentioned techniques, a number of technical, economic, and policy related issues need to be assessed. A summary of the specific issues which need to be addressed and an evaluation of the possible management methodologies are presented in Table 6-1. GHD notes that based on the outcomes of the teleconference, FRNSW do not consider allowing the pit to refill with water to retain it as a collection pond for future PFAS-impacted runoff an option for this site. However, this option has been retained in Table 6-1 for completeness, as these factors were discussed in the teleconference.

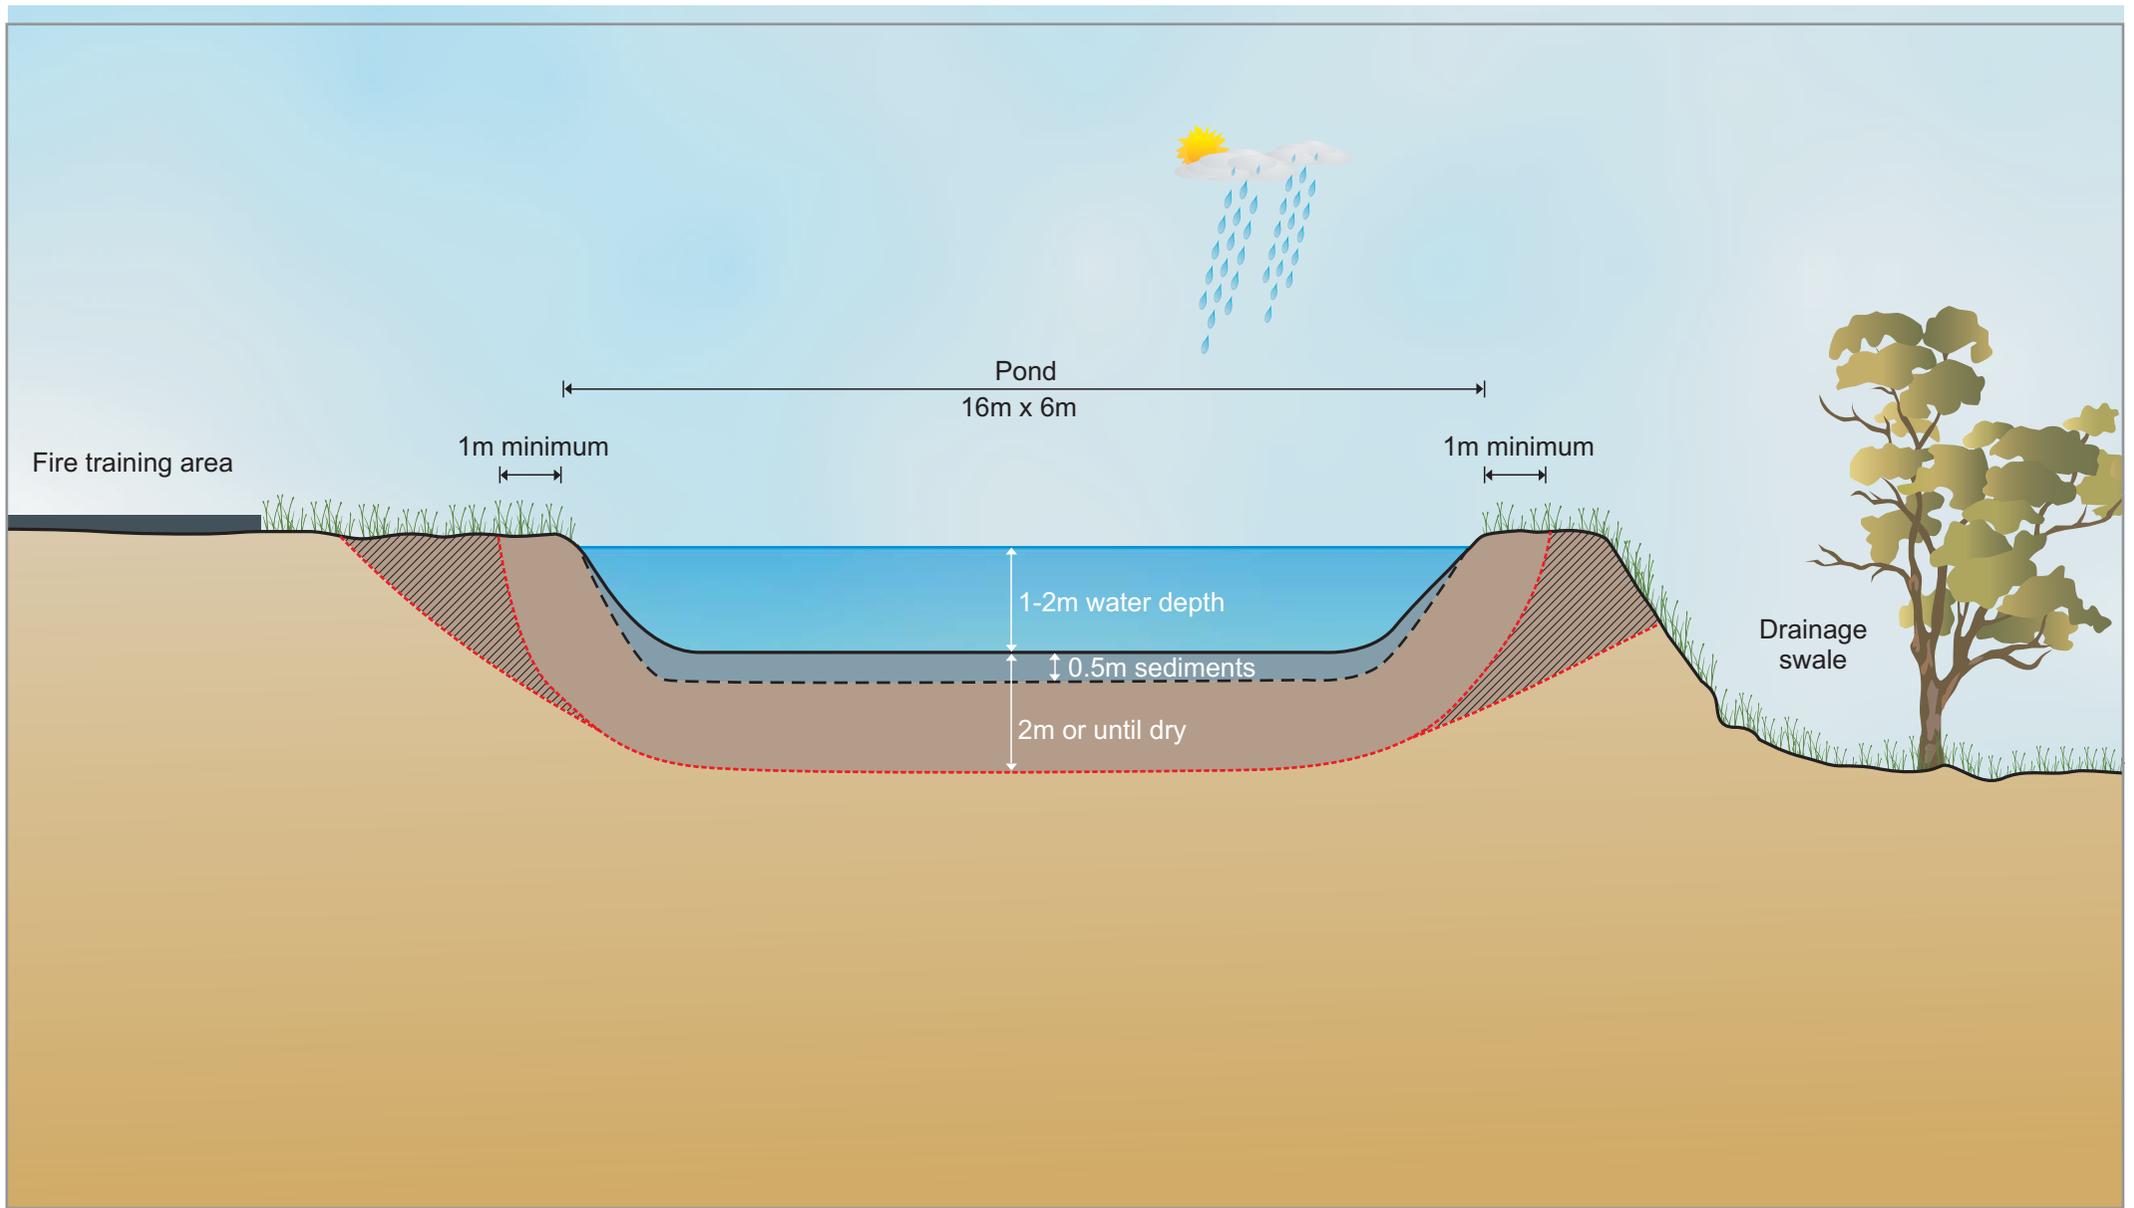
Conceptual diagram only - not to scale

The surface area of the pond is approximately 96 m². Sediments are assumed to extend approximately 0.5 m below the base of the pond (as outlined in the Options Assessment Report, Appendix B) with approximately 1 to 2 m of water above. A rough schematic diagram is shown in Figure 8-1.

GHD proposes that soils are excavated at least 1 m laterally from the edge of the pond, and at least 2 m from the base of the pond (including the assumed sediment layer) or until soils become dry in both the horizontal and lateral directions (whichever occurs first), as shown in Figure 8-1. These distances are based on the goal of removing the mass of PFAS associated with this pond (assumed to be the water component and shallow soils) and minimising waste volumes generated. However, consideration will be given to slope stability when finalising the final extent of excavation and it shall be the contractors responsibility to ensure that the excavation remains stable at all times.

The edge of the hardstand area may be encountered as part of the excavation works depending on final depth and slope stability. This material will require either different disposal compared to the soils beneath or encapsulation in a containment cell. The hard stand material should therefore be broken up and stockpiled separately to the soils.

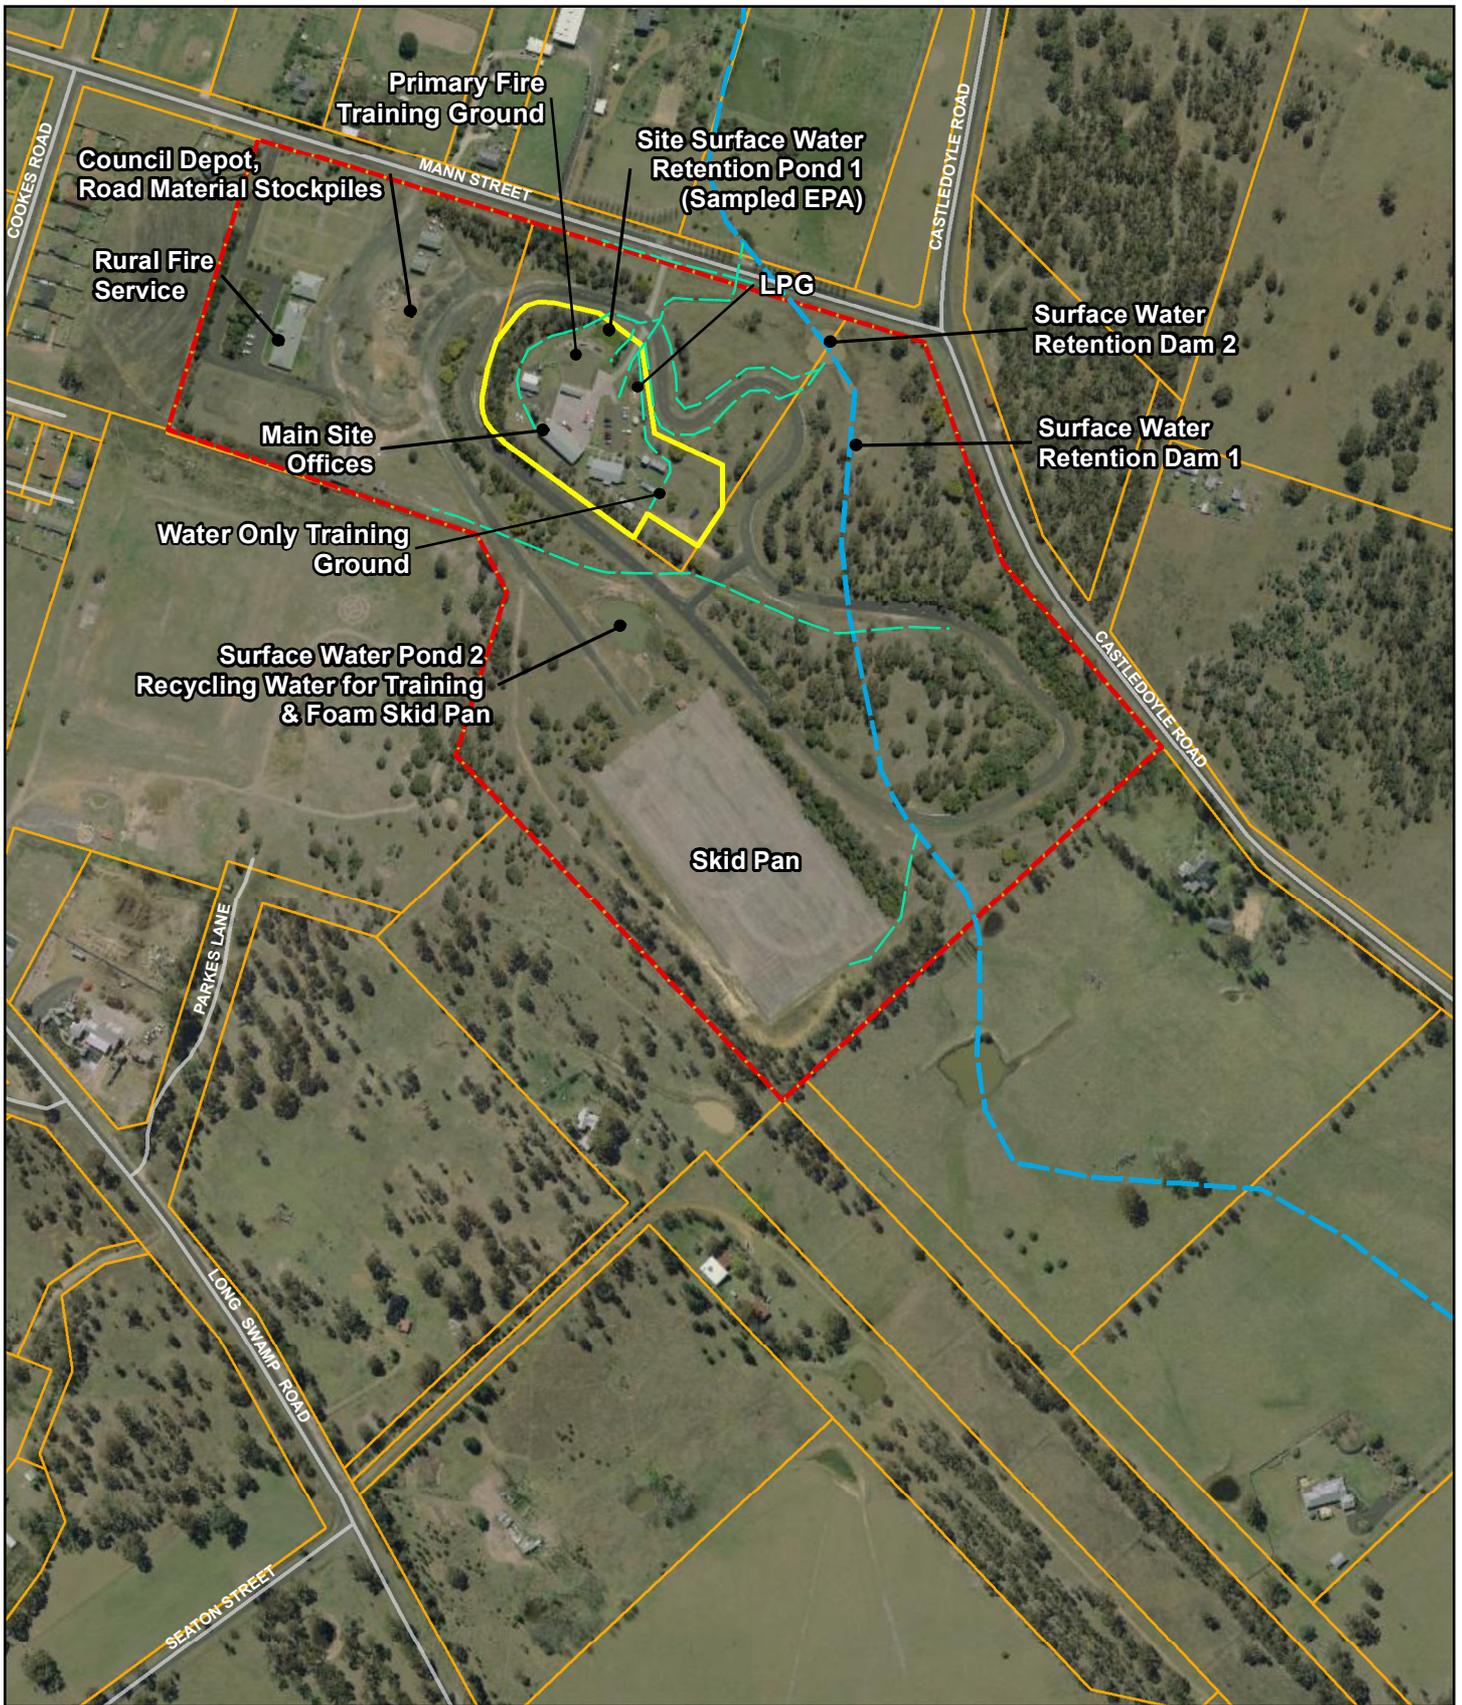
Figure 2

Site Layout

While a mobile water treatment plant is on-site, FRNSW could make use of the facility to dewater the other surface water ponds and dams identified both on and off site which also contain PFAS (refer to Figure 2, Appendix A). This would save FRNSW additional mobilisation costs should they want to treat all potential sources of PFAS impacted water. Such an approach would provide further means of improving surface water quality for neighbouring properties downgradient of the site. However a detailed cost benefit analysis is recommended, including consideration of the volume of PFAS mass which would be removed from the other surface water bodies. It is recommended that additional sampling data is obtained from the surface water bodies to provide current data to feed into this cost benefit analysis.

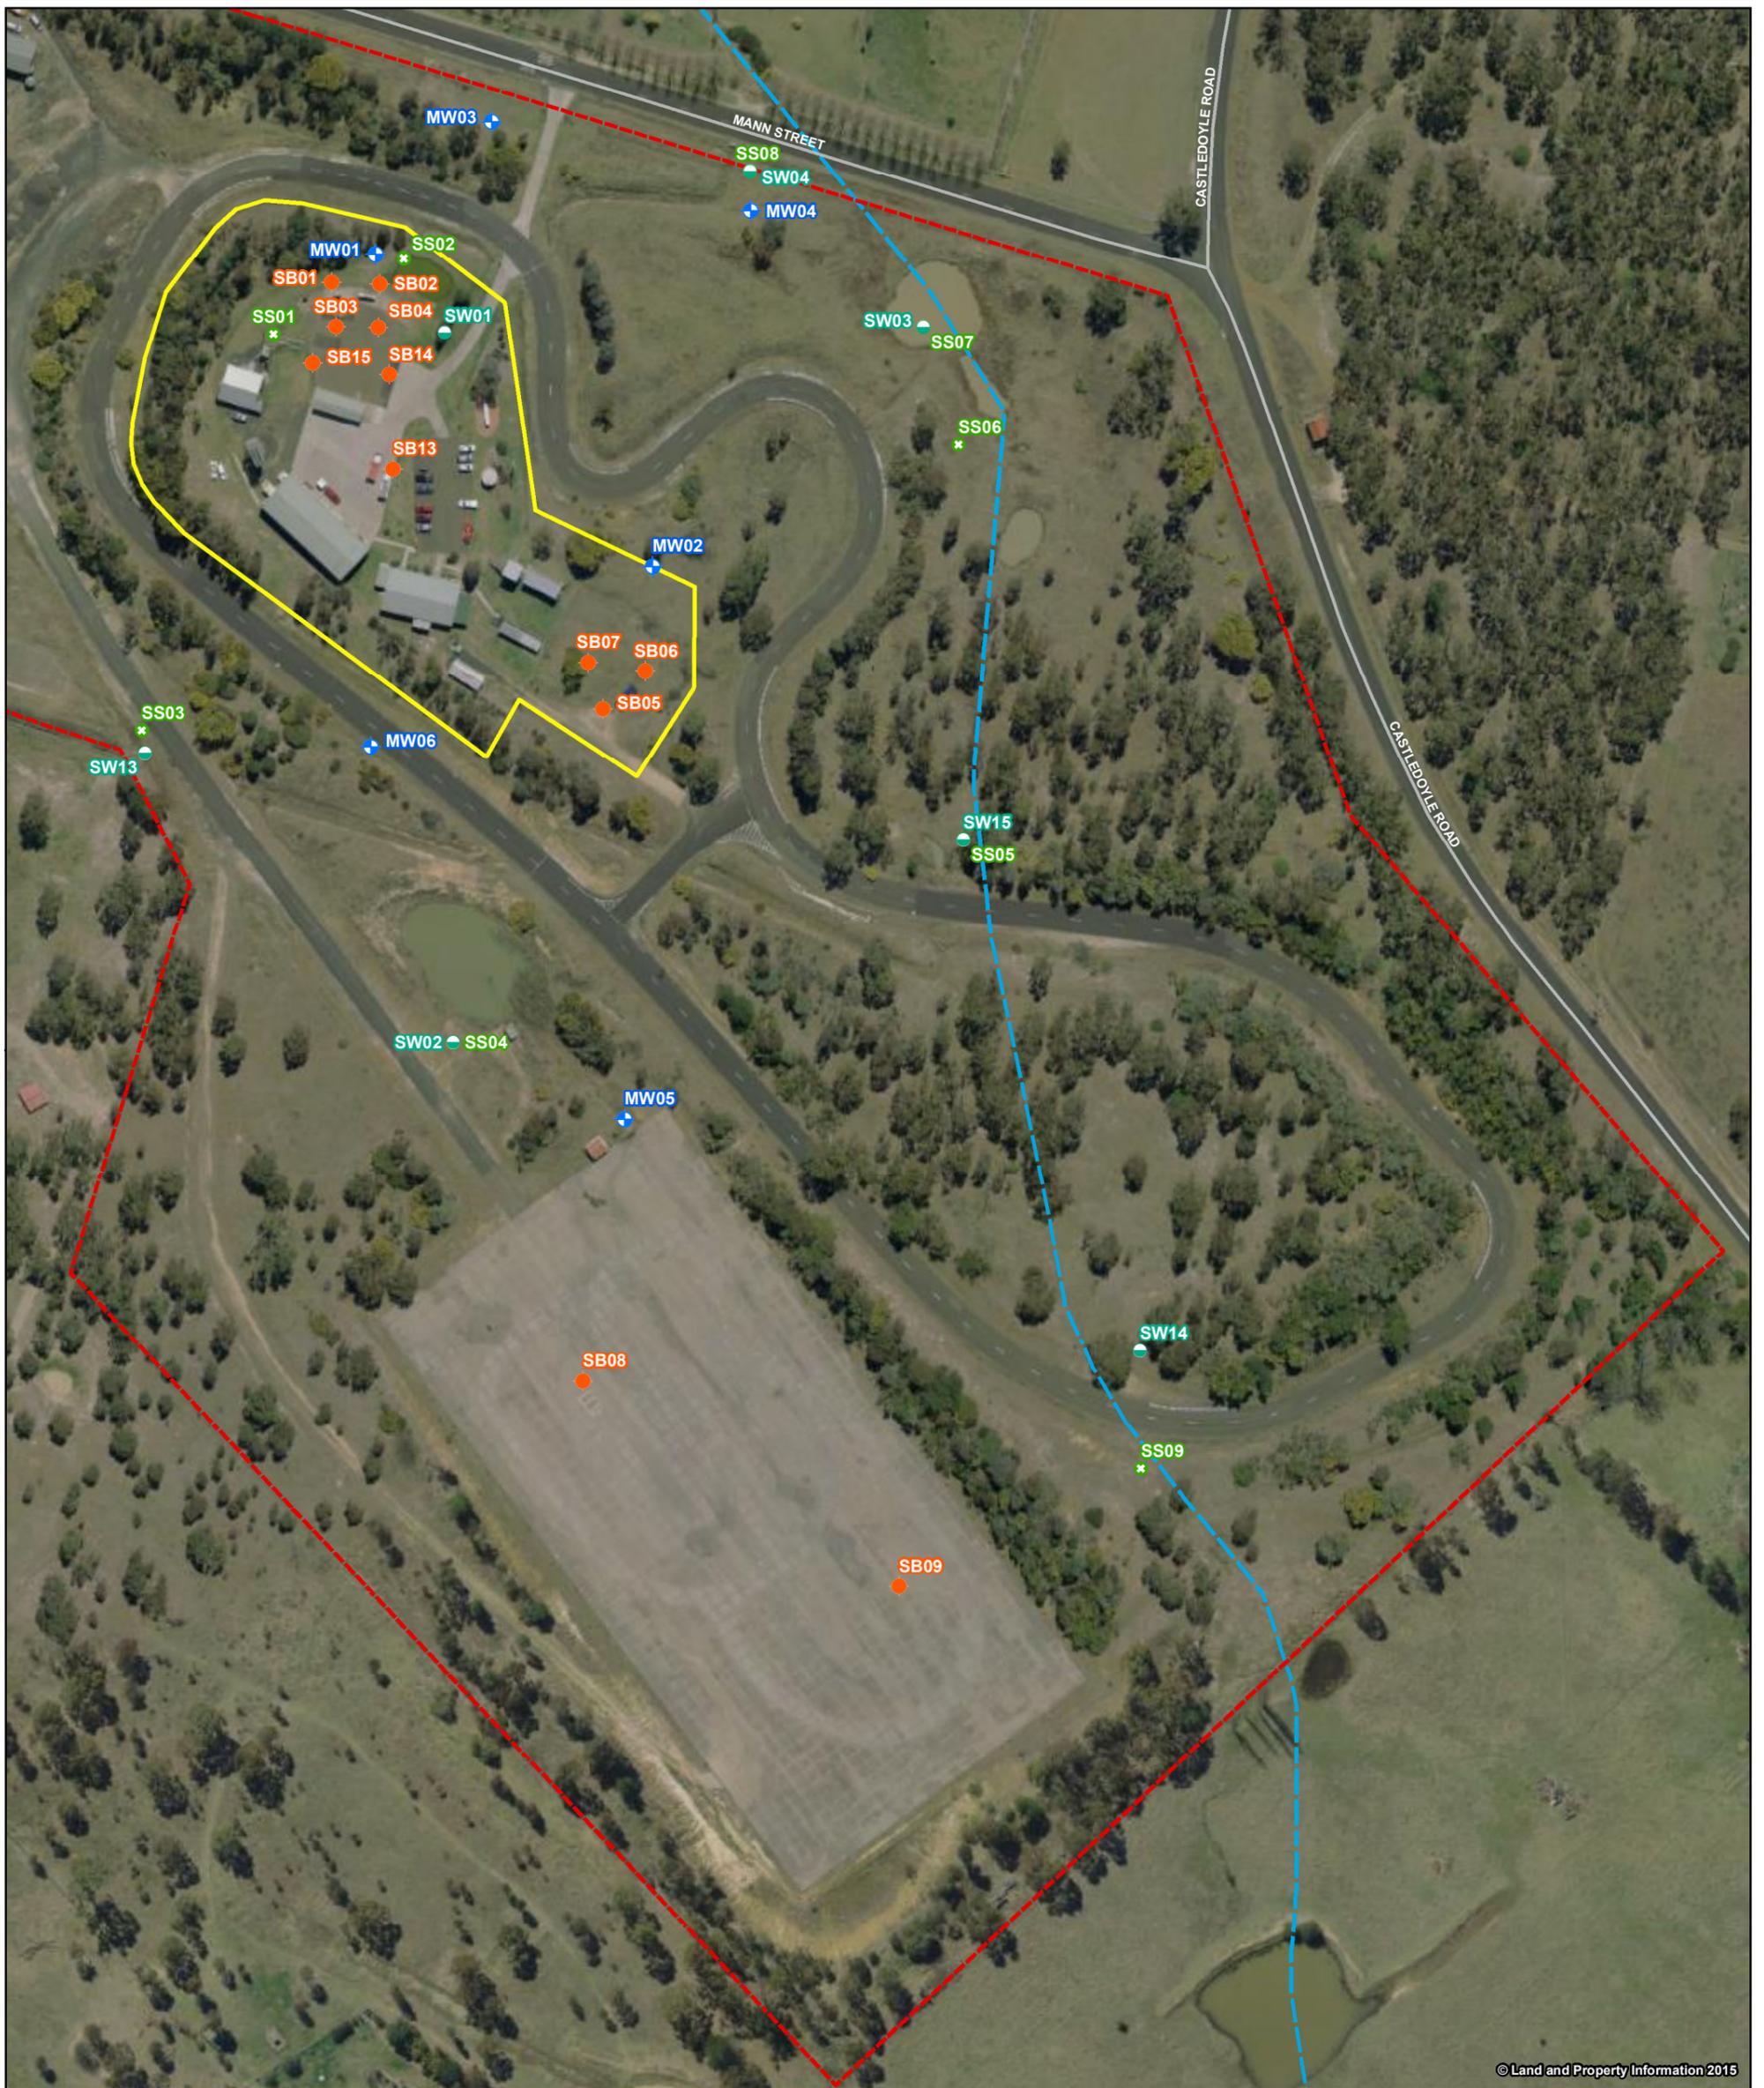
Figure 3A

Investigation Locations (Within the Wider Training Facility)

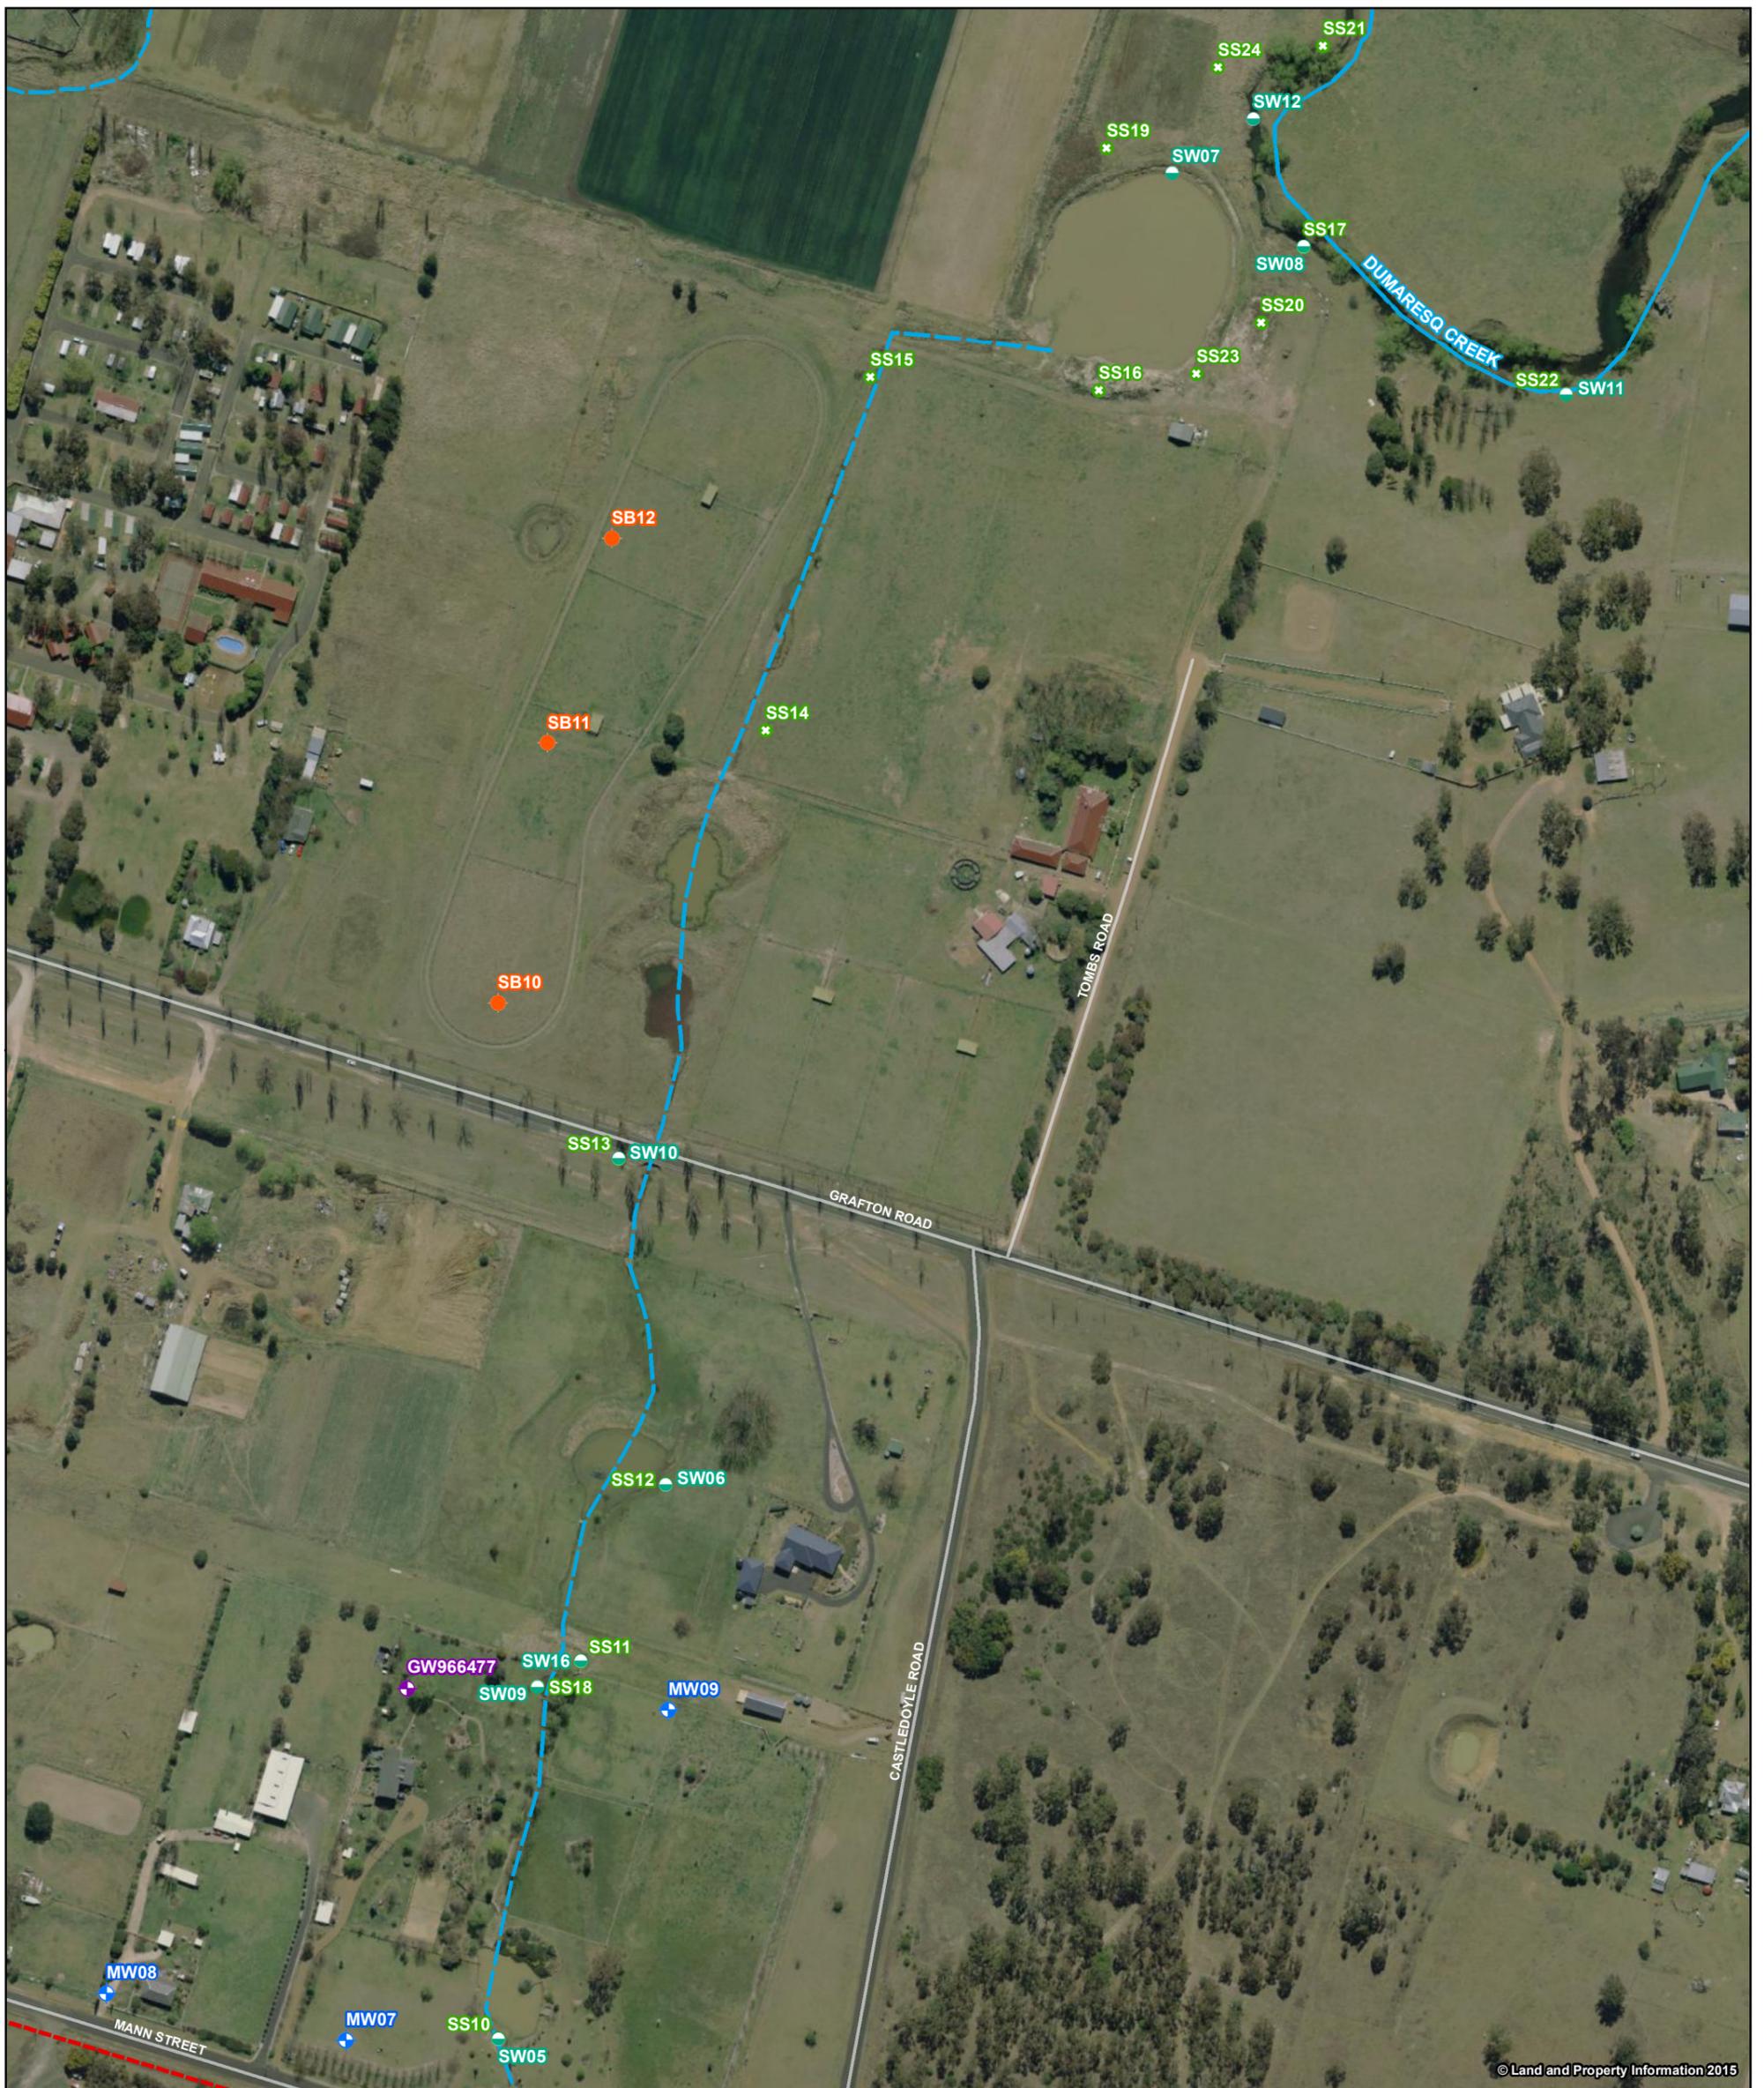
Figure 3B

Investigation Locations (Outside the Wider Training Facility)
